## **B-Vent Safety and Combustible Clearances**

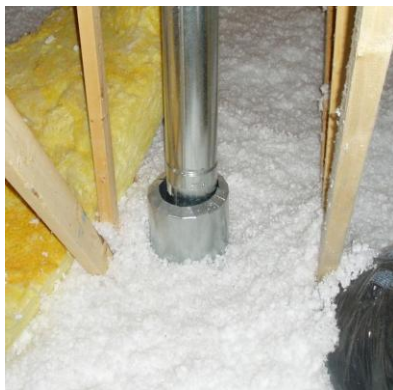
Nice Job!

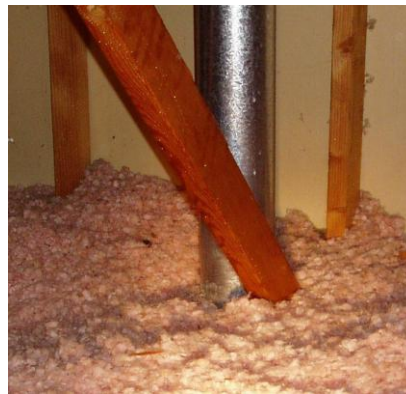
I was rummaging through my inspection photos and found a couple that I thought make a good point about an often seen problem -- combustibles packed around the B-vent in the attic. Especially in older homes, time and time again, the inspector sees insulation resting in contact with the B-vent. A B-vent is the metal duct that is normally used to vent gas and propane appliances such as furnaces and water heaters. These vents can achieve temperatures of 300 degrees when gas appliances are operating. Therefore, insulation, including fiberglass, should be a couple inches away from a B-vent to eliminate the hazard of a fire. This is easily accomplished if a homeowner gets a piece of sheet metal and bends a collar or a ring of metal to fit around the vent. Tack it in place, remove all insulation between the ring and the vent, and the job is done. In a newer home, a commercially manufactured shield is often put in when the vent is installed. The photo on the right is the concern that an inspector sees frequently at an older home -- it seems to be a problem most of the time in older houses. The vent on the left is neatly done with a collar or shield made for that purpose in place. This is at a newer house. I hope this description and the photos clarify an often misunderstood, but easy to fix, concern.

No clearance to vent!
